Aerial Photograph Anomaly APHO 1
Aerial Photograph Anomaly Program
Marine Corps Air Station, El Toro, California

27 January 2000

Prepared by
Southwest Division, Naval Facilities Engineering Command
BRAC Program Office
1230 Columbia Street, Suite 870
San Diego, CA

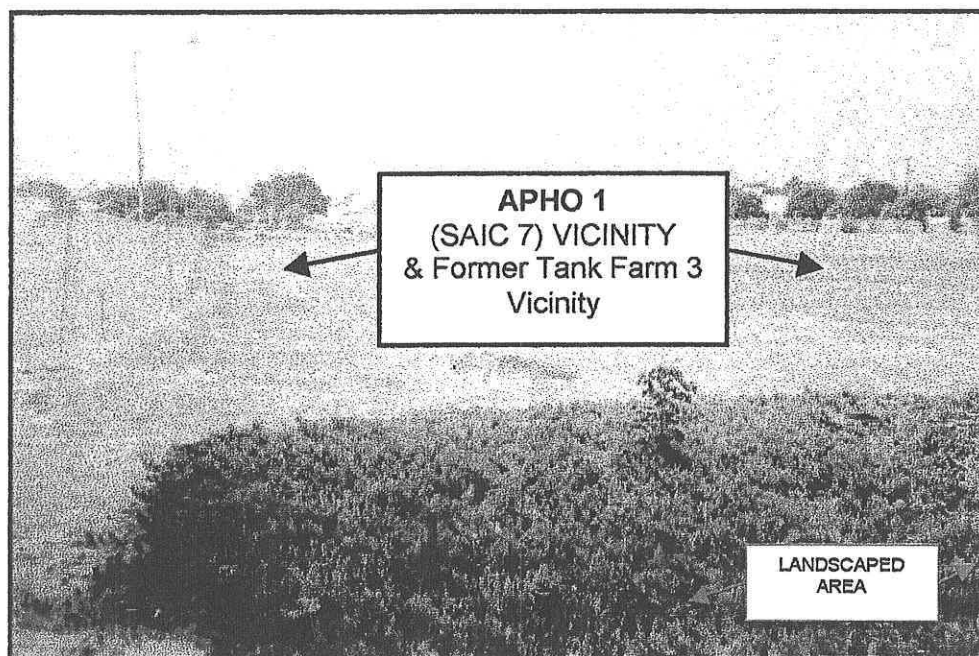
**Photograph 1. APHO 1 (SAIC 7) Vicinity.
Stains (identified on 1946 aerial photograph).
Aerial Photograph Anomaly Program
Marine Corps Air Station, El Toro**

Date of Photograph: 5 September 1999

- The APHO 1 vicinity was visually inspected by Navy representatives in September and December 1999, and no evidence of stains or discolored areas was observed.

Current Site Conditions: *APHO 1 (SAIC 7) is located within the boundary of the former Tank Farm 3. The site is relatively level and is covered with grass. No stained or discolored areas were observed during the site visits, and no items were being stored at the site during the site visits. Building 624 located northeast of the site was vacant at the time of the inspections.*

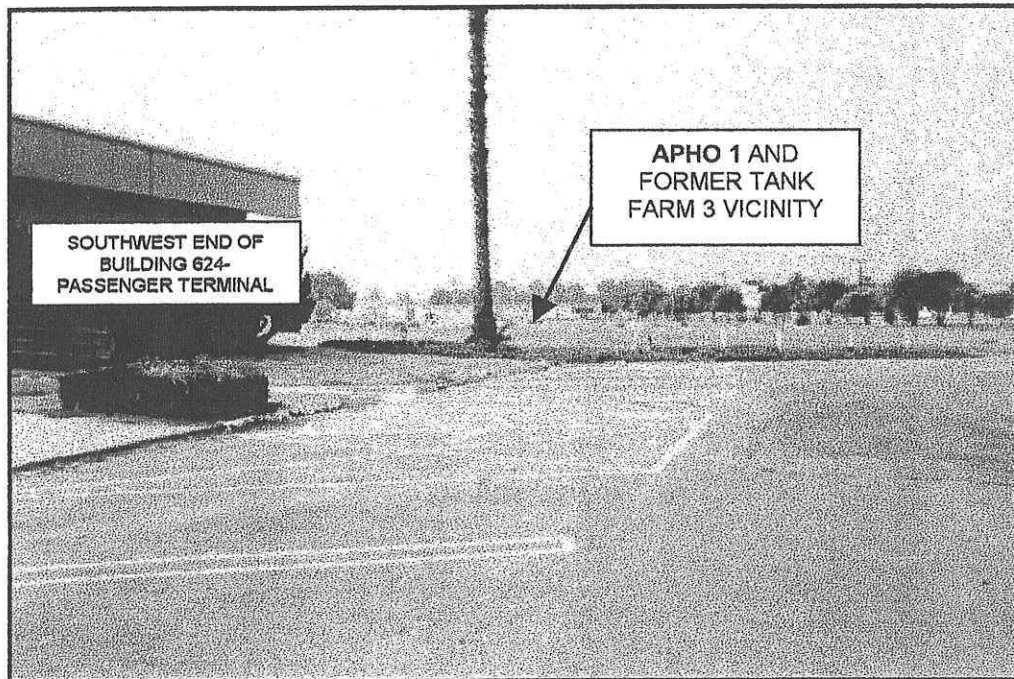
**Photograph 2. APHO 1 (SAIC 7) Vicinity.
Stains (identified on 1946 aerial photograph).
Aerial Photograph Anomaly Program
Marine Corps Air Station, El Toro**

Date of Photograph: 5 September 1999

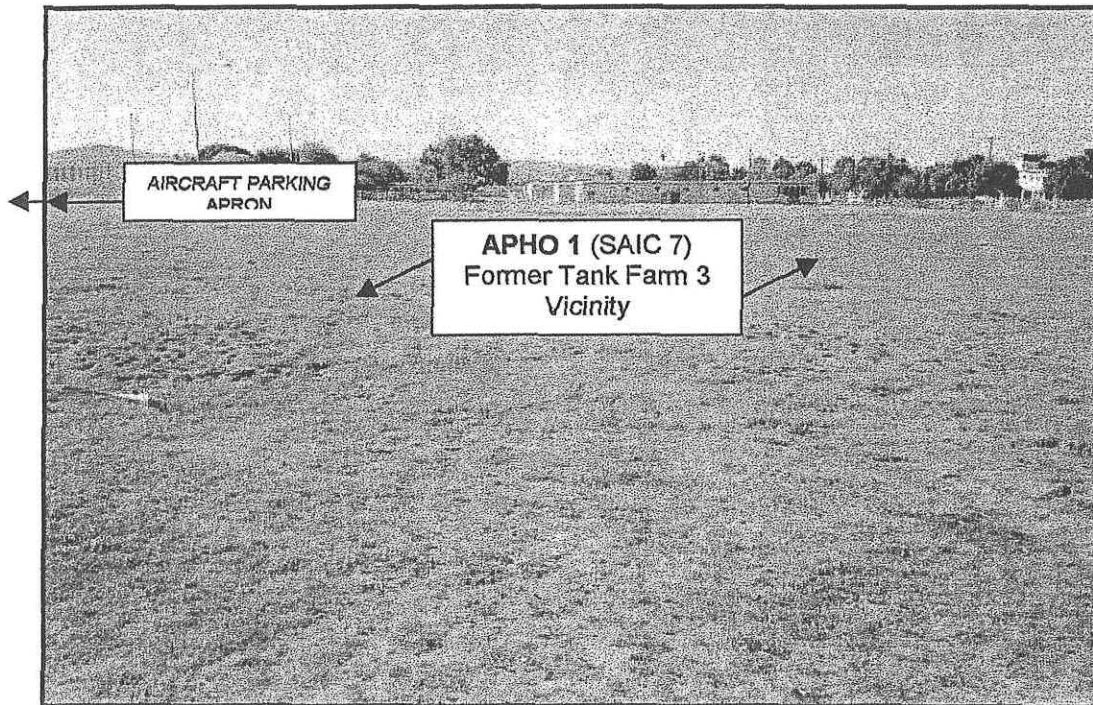
**Photograph 3. APHO 1 (SAIC 7) Vicinity.
Stains (identified on 1946 aerial photograph).
Aerial Photograph Anomaly Program
Marine Corps Air Station, El Toro**

Date of Photograph: 19 December 1999
